Fungal Degradation of Military Assets

Brenda Little, Patricia Wagner, Dennis Lavoie and Richard Ray

**Naval Research Laboratory
Stennis Space Center, MS 39529**

Three case histories of biodeterioration due to fungi are reviewed. Fungal accelerated deterioration has recently been documented in aircraft fuel storage tanks, painted interior surfaces of helicopters, and wire highlines stored in humid environments on wooden spools. In addition to the obvious esthetic problems requiring expensive, labor intensive amelioration, growth of fungi can cause microbiologically influenced corrosion (MIC).

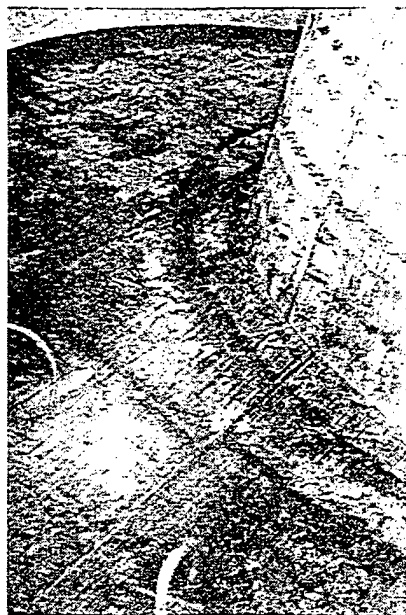
Sections of wood from spool interiors and pieces of brown shipping paper from spool rim edges (Fig. 2) were removed. Wood and paper samples with fungal fruiting bodies, spores, or mycelia were placed in Petri dishes with potato dextrose agar (PDA) and incubated in a dark room at 37°C. After a 1-week incubation, fungal species were identified as *Aspergillus niger* and *Penicillium* sp. The pH of the condensate within Petri dishes and in areas adjacent to growing fungi were monitored using a microelectrode with a tip diameter of 2.4 mm vs. saturated calomel reference electrode. Condensate in Petri dishes where either isolate was grown dropped from a pH of 7.0 to 4.9 in three weeks. Coated wire rope was exposed to pH 5.0 citric acid solution. Localized corrosion (Fig. 3a, b) was observed in each location the acid solution touched the rope.

Figure 2 - Inside surface of wooden spool; white deposits are the result of fungal growth.

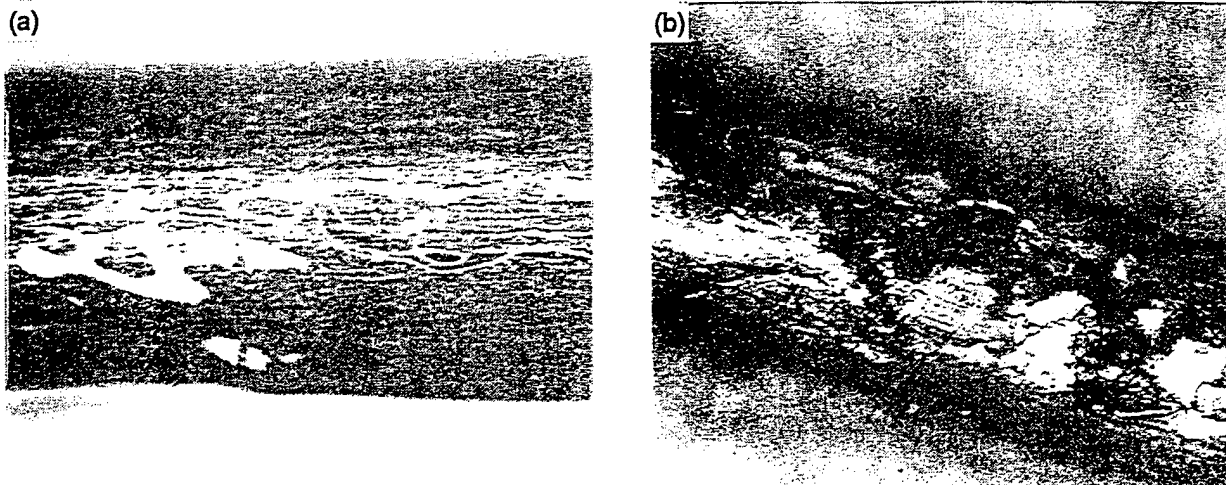
with fungal-contaminated wood may be due to either organic acid production or to initiation of corrosion nucleation sites. Citric acid solution at pH 5.0 did penetrate the protective grease and cause corrosion. Wire rope in direct contact with inoculated wood and agar was colonized by fungal mycelia and fungi were associated with corrosion products. In addition to organic acid production, fungi produce copious amounts of carbon dioxide. Carbon dioxide reacts with water to form carbonic acid. In our laboratory studies, condensates in covered, inoculated trays were in the range of pH 4.0–5.0. The acidic condensate penetrated the protective maintenance coating. Areas where the maintenance coating had been mechanically removed were particularly vulnerable to attack by acidic condensates.

Figure 3 – (a) Strand of wire with protective grease intact before exposure to acidic solution, 30x. (b) Localized corrosion after exposure to citric acid solution at pH 5.0, 40x.

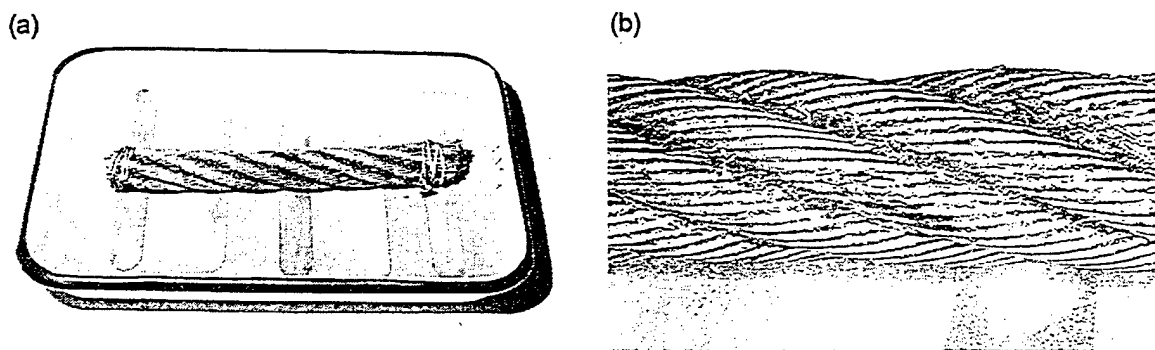
Wire rope received directly from the manufacturer was exposed on wooden tongue depressors in enamel trays containing PDA. Some trays were inoculated with fungi, covered with a clear plastic, and placed in a dark, 30°C environment. Other trays were inoculated but remained uncovered. Controls were uninoculated and covered. Wire rope in contact with wooden tongue depressors inoculated with either isolate developed localized corrosion in areas in direct contact with either the wood or the agar within four days (Fig. 4a, b). Fungi were attached directly to the wire and were associated with corrosion products in all inoculated trays (Fig. 5a, b, c). In the open, inoculated tray no additional corrosion was observed. No corrosion was observed in the abiotic, covered control. In the covered inoculated trays, corrosion developed in areas where condensate dripped onto the wire from the clear plastic in addition to areas in direct contact with wood and agar. Localized corrosion was observed on wire surfaces where the grease coating was thin or missing due to handling. In these cases, fungal cells were not associated with pitting and corrosion products. The maintenance coating is an amber-colored wax with organic corrosion inhibitors. The product, which has negligible solubility in water, was evaluated as a source of nutrients for the fungi by melting the grease in a Petri dish, allowing it to solidify, inoculating it directly with the isolates, and comparing to an abiotic control. Fungal isolates did not grow on the maintenance coating. Fungal growth could not be demonstrated on corroded rope sections not in direct contact with wood or agar.

Figure 4 – (a) Wire rope placed on wooden tongue depressors in a tray containing PDA inoculated with *Aspergillus niger*. (b) Wire rope that had been in contact with wood and PDA inoculated with *Aspergillus niger*. Rope rolled aside to show localized corrosion after contact with agar or wood.

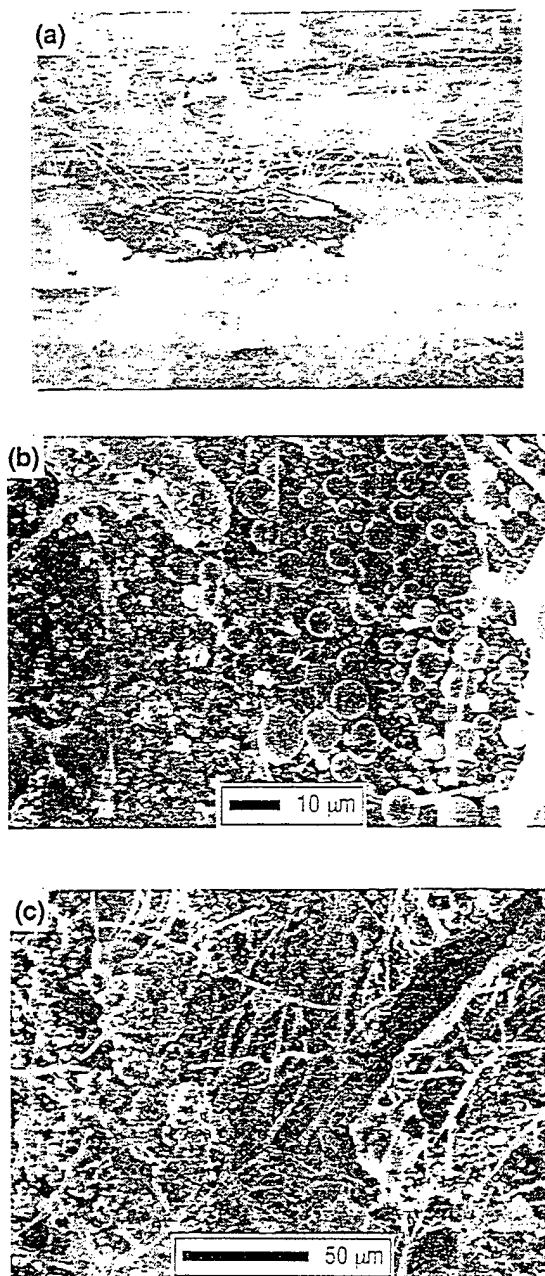
Figure 5 – (a) Light microscope photograph showing fungal mycelia attached directly to wire and associated with localized corrosion, 40 \times . (b) ESEM micrograph showing mycelia in association with corrosion products, 500 \times . (c) ESEM micrograph showing mycelia in association with corrosion products, 1000 \times .

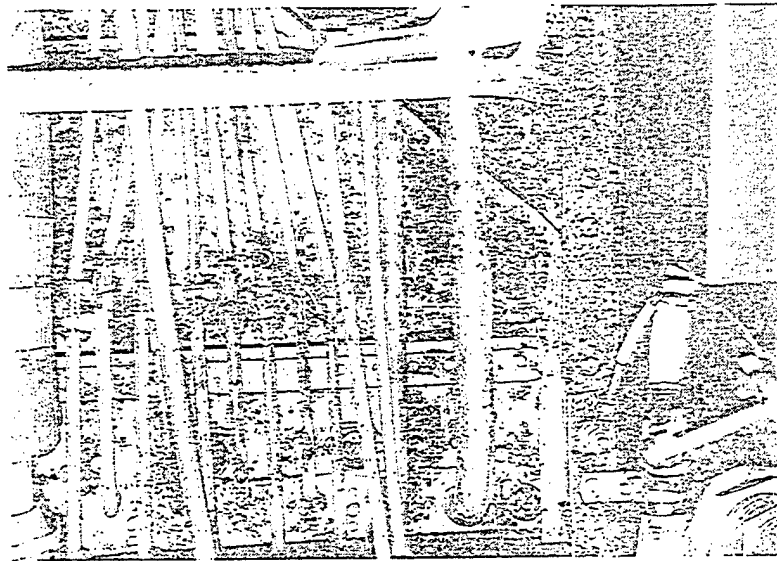
Military helicopters operating in humid environments mildew or mold on interior surfaces (Fig. 6).³ Cleaning accounts for a significant amount of the labor expended in field maintenance activities. In extreme cases, fungal growth has been known to form thick masses, especially in areas of the craft not regularly cleaned in the field, such as the bilge, behind sound insulation blankets, within tight spaces in the overhead, and behind fixed equipment such as electronics racks. Growth in such areas may not be discovered until aircraft are sent for depot-level maintenance after 5 to 7 years. Occasionally, aircraft placed in storage for a short time are so badly contaminated with noxious growth that they are unusable and must be returned for costly, depot-level recleaning.

Figure 6 — Fungal growth on interior of H-53 helicopter.

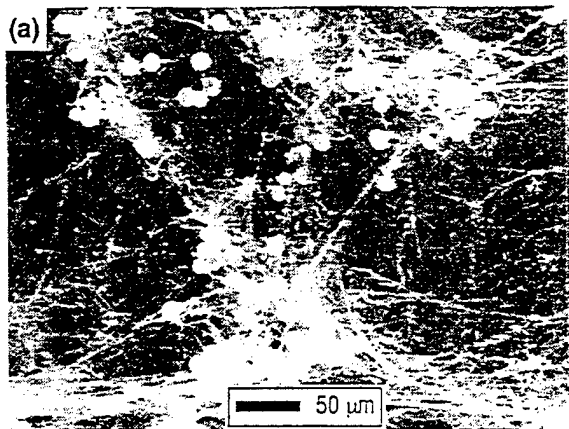
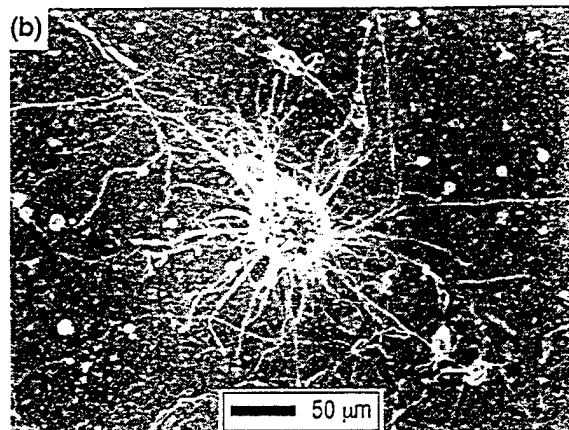
Fungi on polyurethane surfaces appeared well established, with mycelia and conidia (Fig. 8a), and germinating spores (Fig. 8b), but there was no obvious degradation at attachment points. Figure 9 illustrates incomplete removal of fungal structures by simulated field cleaning procedures. Hyphae were present in the experimental scratches on many coupons, and occurred in association with both occasional corrosion products in unbleached portions and thick corrosion products on the bleached portions.

Figure 8 — (a) Mycelial mass on polyurethane coated coupon after 30 days (250×) and (b) germinating mycelia on polyurethane coated coupon after 30 days (250×).

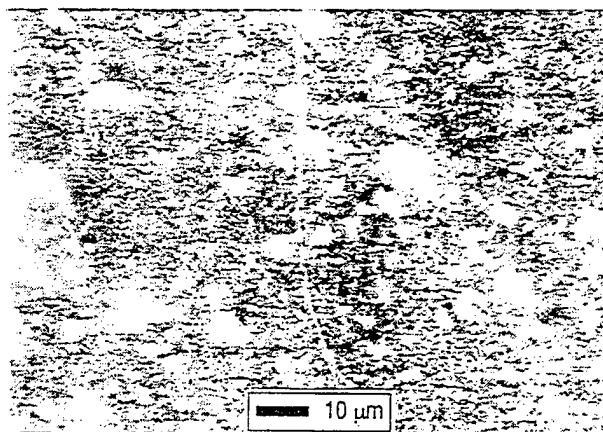
The lower colonization rates for polyurethane compared to lacquer suggest this coating was less susceptible to initiation of fungal growth. In this short experiment, no surface degradation of polyurethane coatings was observed microscopically where fungal hyphae were attached. Simulated field cleaning/disinfectant procedures using 75% ethanol physically removed most fungal structures from paint surfaces; the viability of the few remaining fungal structures was not assessed. Operationally, short term exposure of polyurethane paints to fungi (on the order of weeks) appears to result in no physical damage to the coating surface, and alcohol cleaning appears to be effective. Prolonged or multiple exposures to fungal contamination may have a cumulative effect on coating performance. Performance also may be a function of substratum, as indicated by the observation that polyurethane paint disbonded from a glass fiber composite structure under a thick fungal colony while the surrounding surface remained intact.

Figure 9 — Polyurethane coated coupon surface after alcohol cleaning (1000×).

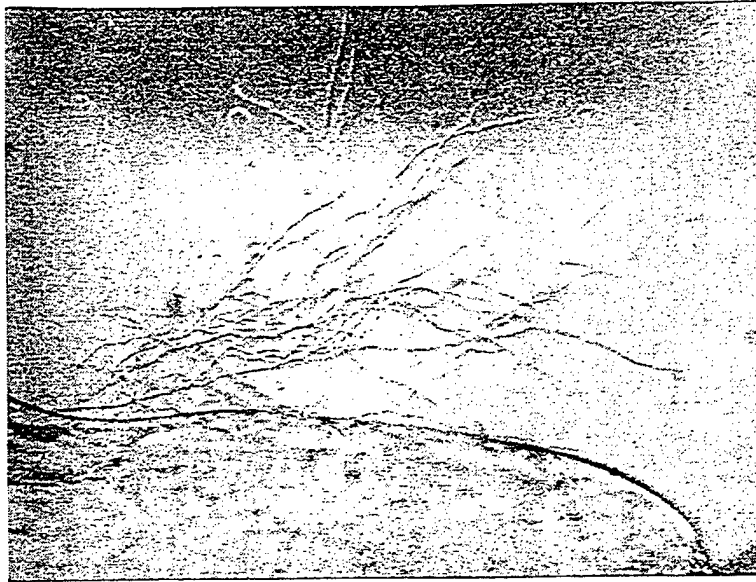
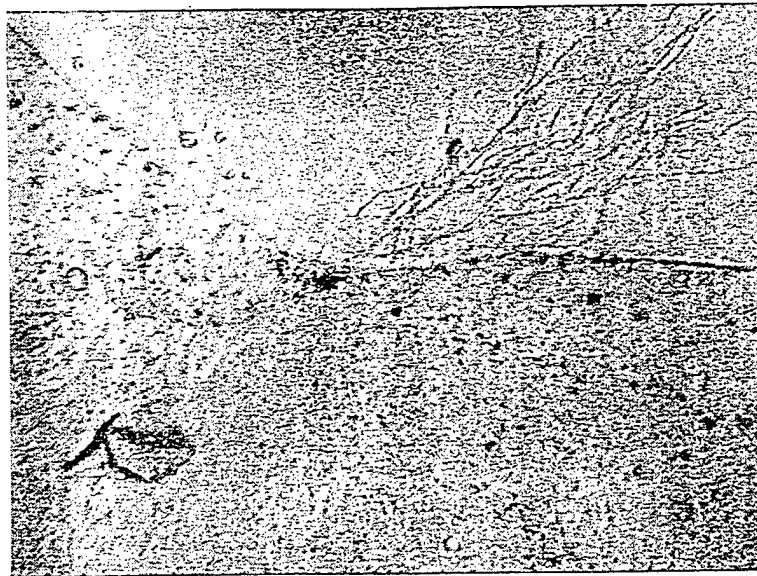
Extensive localized corrosion of the bottoms of carbon steel jet fuel storage tanks with subsequent leakage of fuel oil was recently investigated. *Hormoconis* (formerly *C. resiniae*), *Aspergillus*, *Penicillium* and *Fusarium* were identified in the fuel/water mixtures. Corrosion attack was located near the tank bottom at the fuel/water interface where an active microbiological population was associated with free water. Fungi were observed growing over the entire surface of oil droplets and within suspended water droplets (Fig. 10). In the absence of water, no fungi were detected. Water soluble biocides are routinely added to fuel to prevent microbial growth. Problems occur when the biocides are exhausted or the amount of water has been underestimated. Attempts to form emulsions of fuel/water combinations accelerate fungal growth by increasing the surface fuel/water interfacial area and, therefore, the availability of oil, oxygen, and nutrients.

Figure 10 — Fungal mycelia in association with water droplets in jet fuel.
